Situation Photo Log

Thursday, January 3, 2013

Kalamazoo River / Enbridge Spill

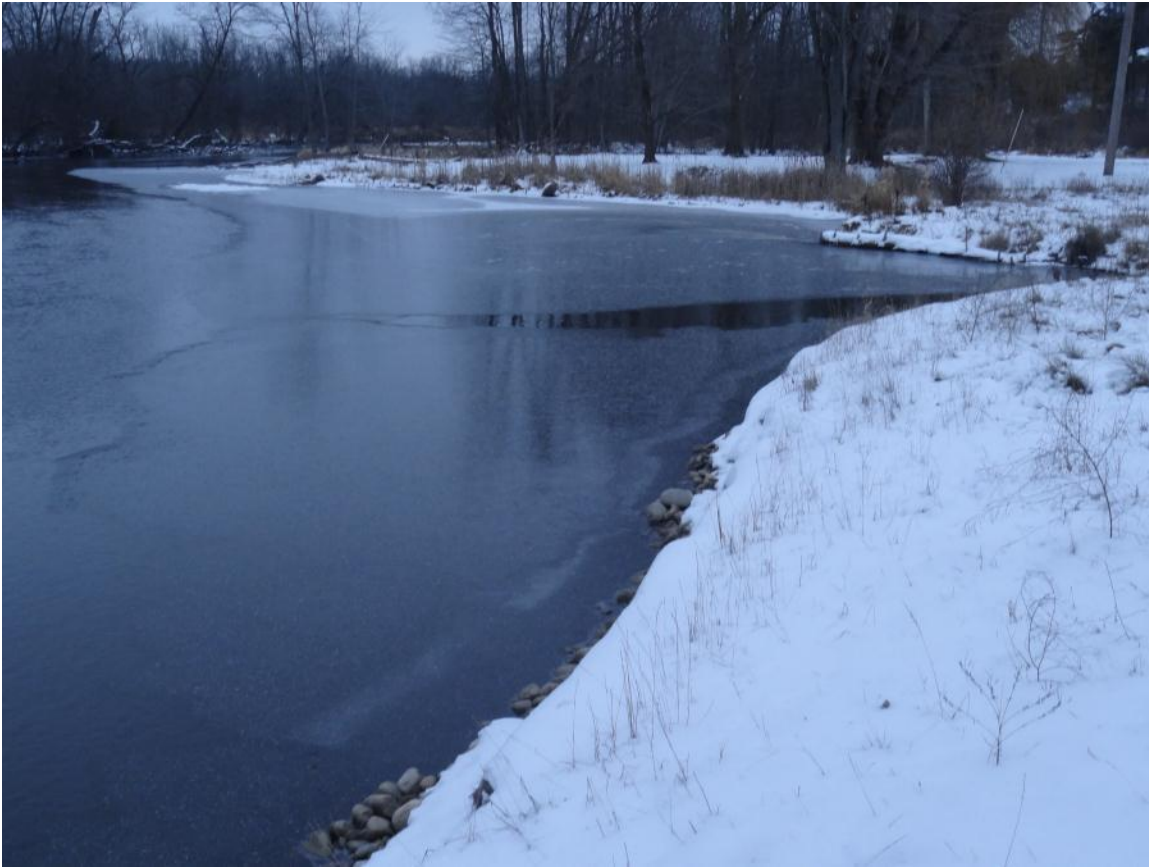
1. Confluence, bank ice observed has increased from yesterday.

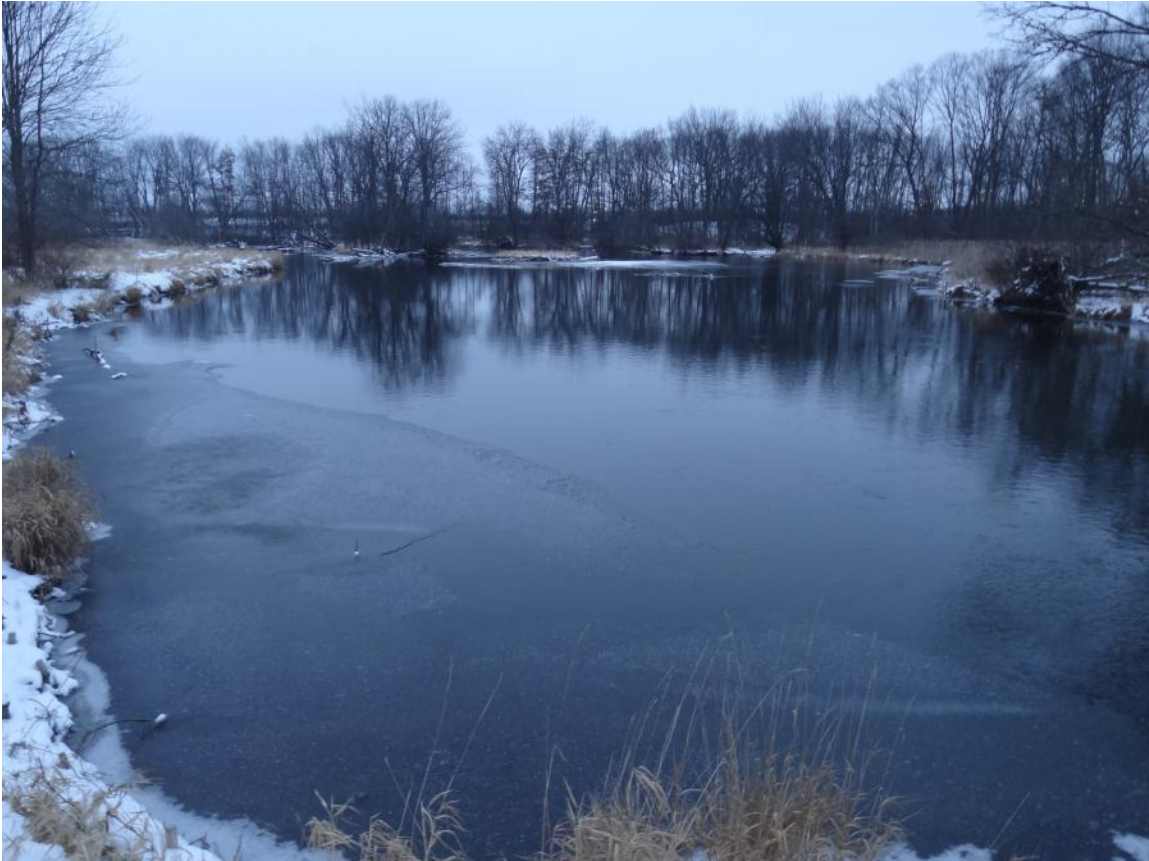
2. MP2.25 LDB, minor bank ice observed.

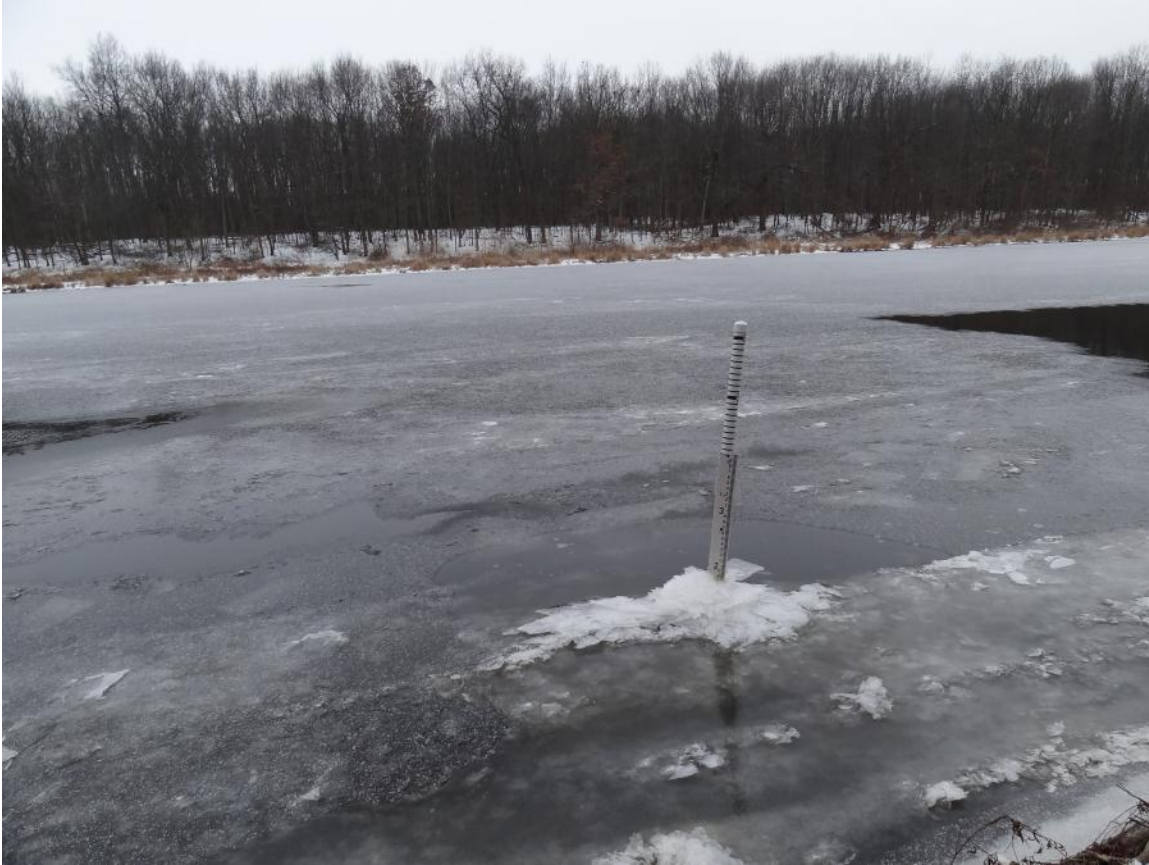
3. Water Gauge at C0.4 Boat Launch. Ice observed covering the majority of the river channel.

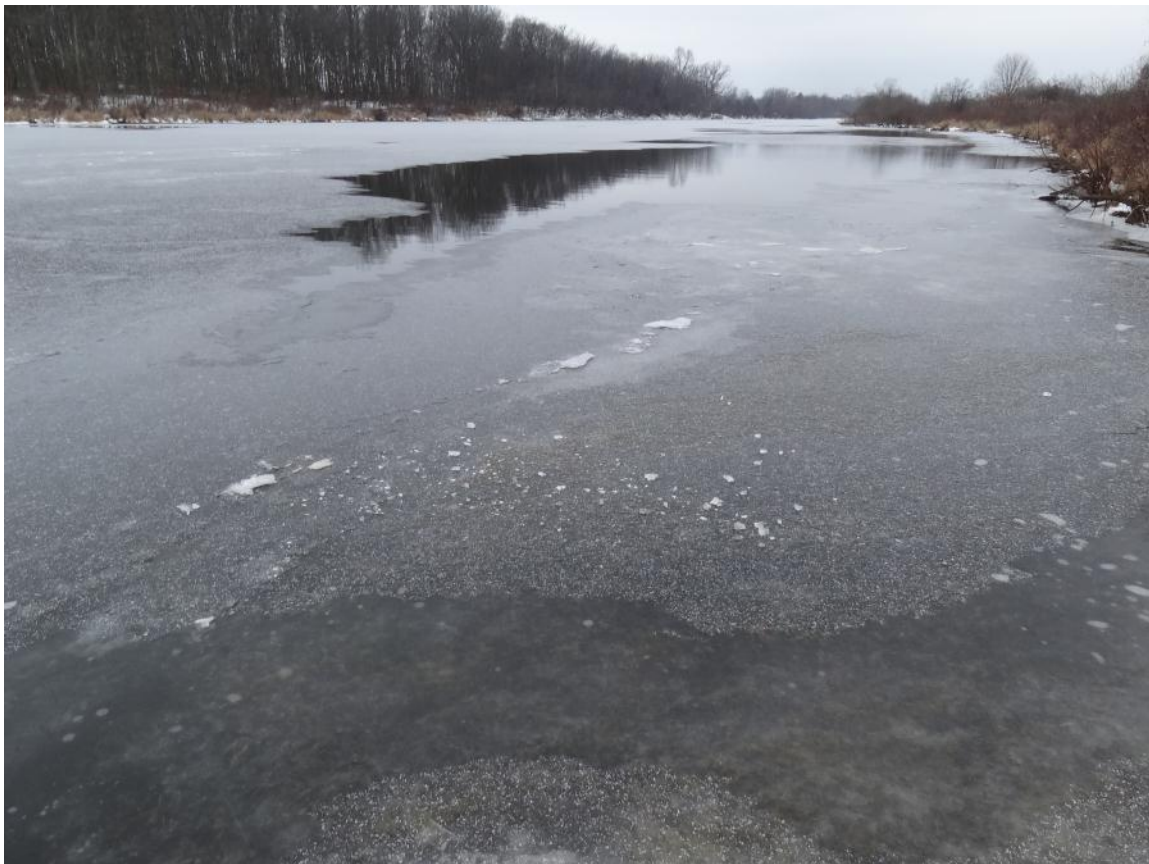
4. Looking west from C0.4 Boat Launch. River channel moderately covered in ice.

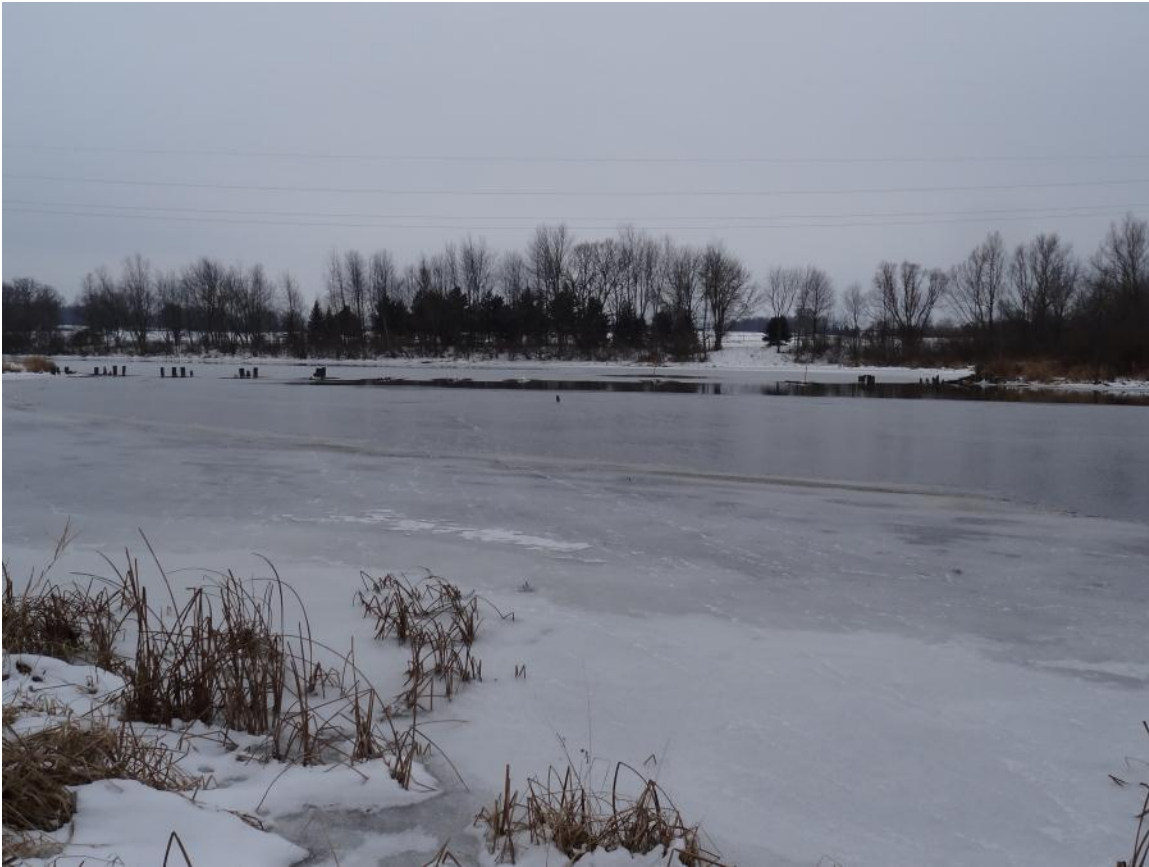
5. MP5.63 Ceresco Dam trestle, area covered by ice in vicinity of trestle has increased slightly from yesterday.

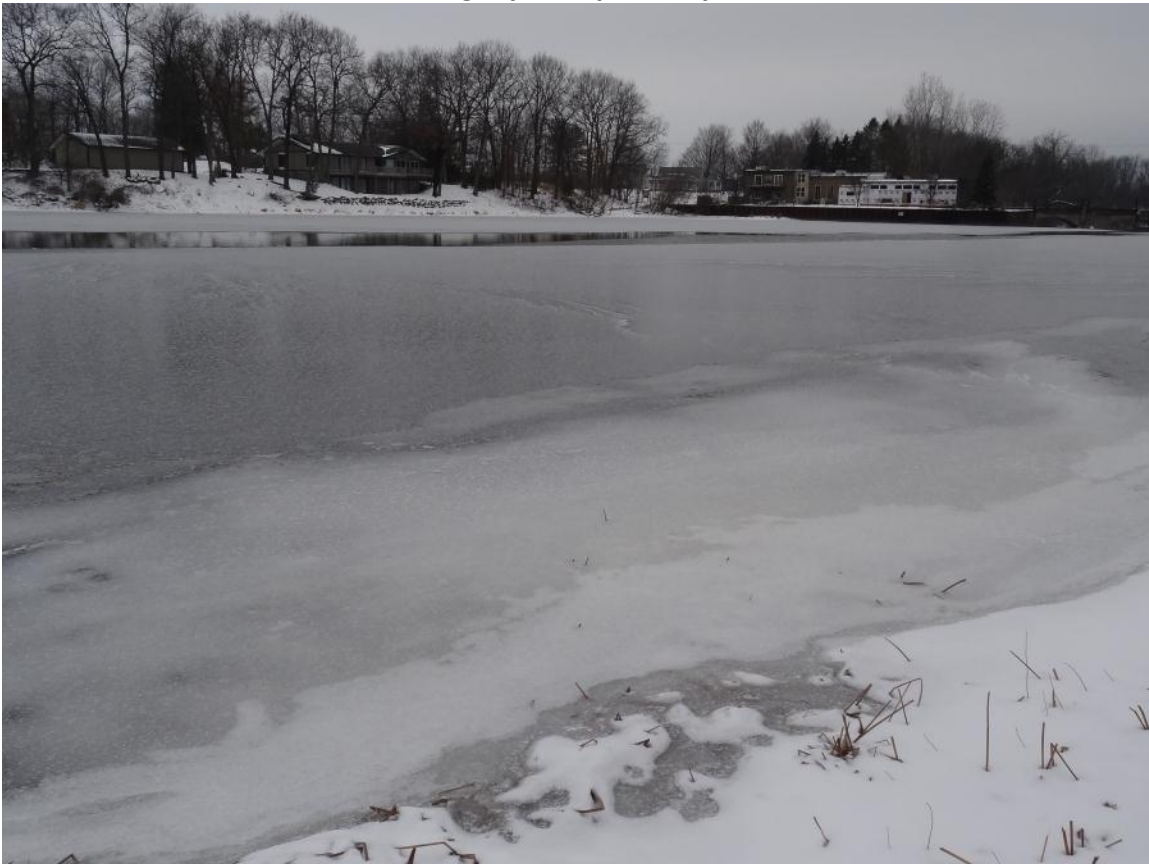
6. MP5.70, ice and snow observed along both river banks. River channel remains open with no ice observed in channel.

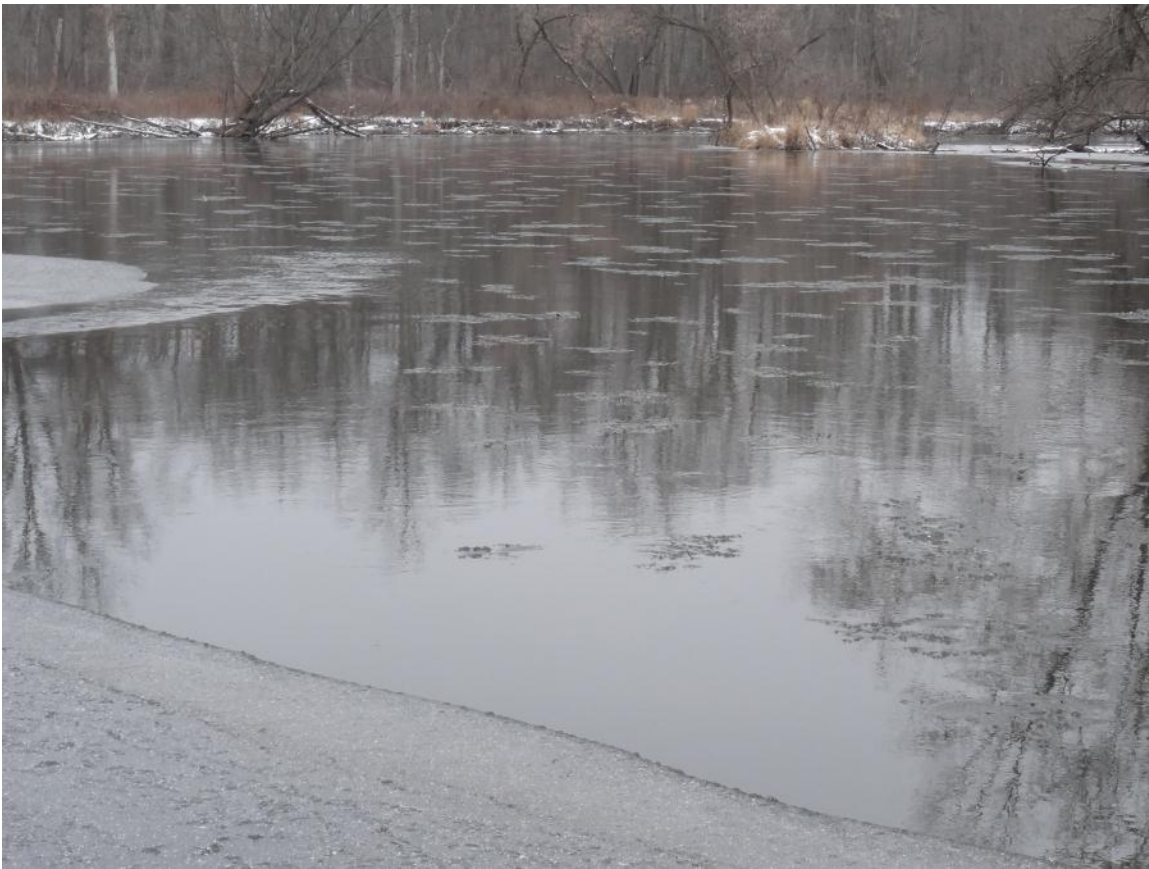
7. C3.2 Boat Launch, frazil ice observed flowing downstream in river channel.

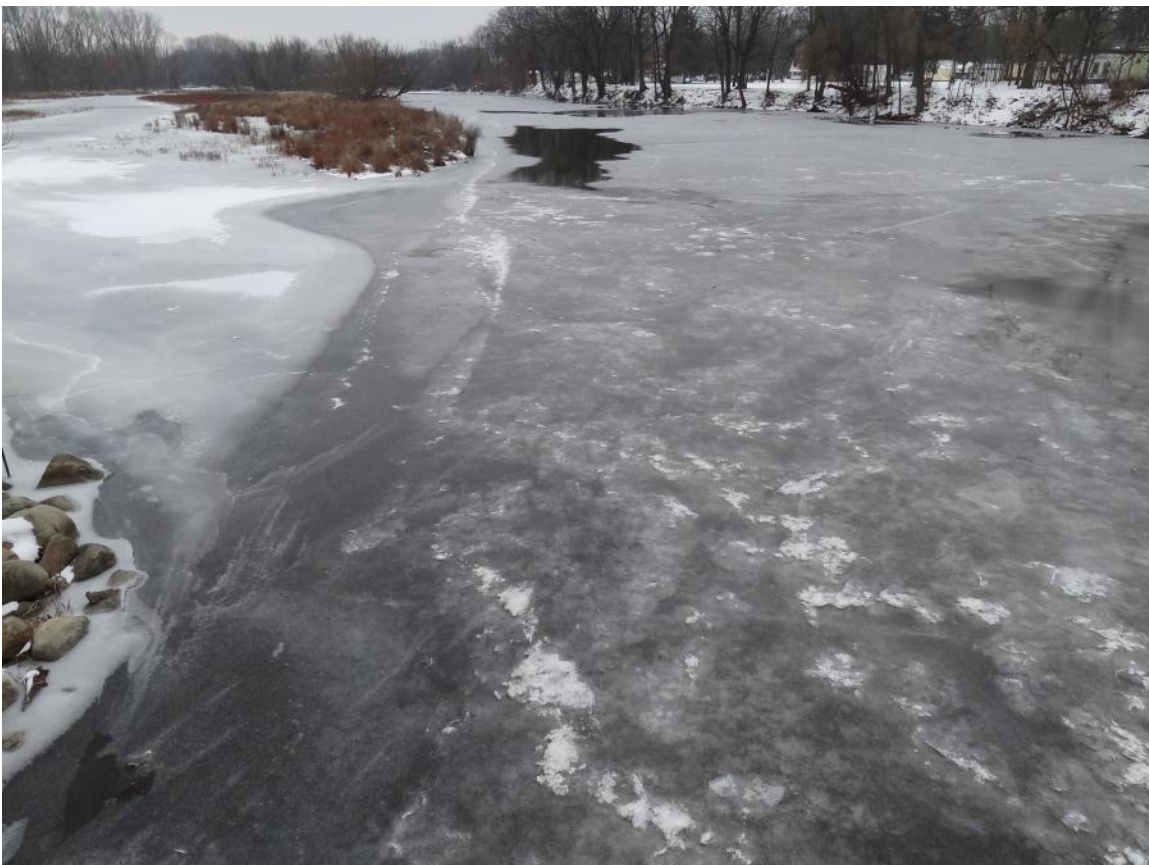
8. MP 15.25 South Mill Pond. Majority of river channel covered in ice.

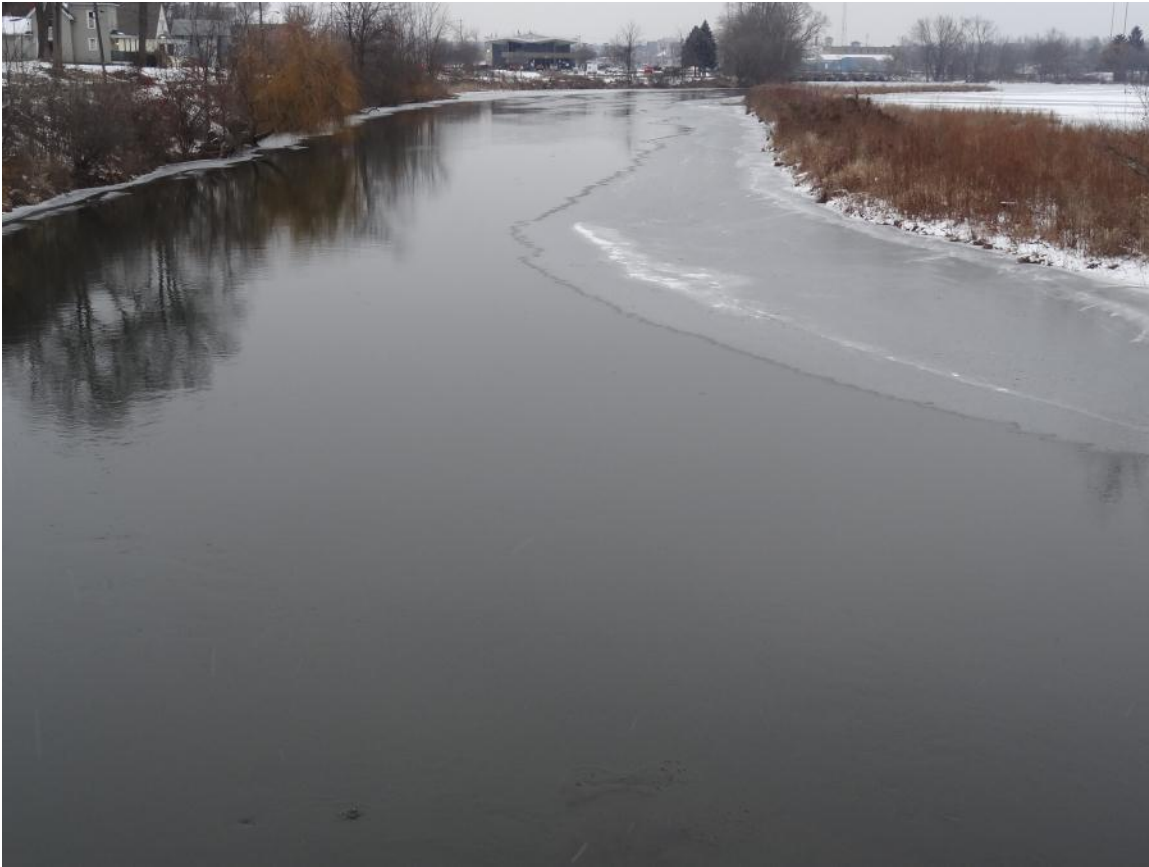
9. MP15.50 North Mill Pond, bank ice observed along river channel.

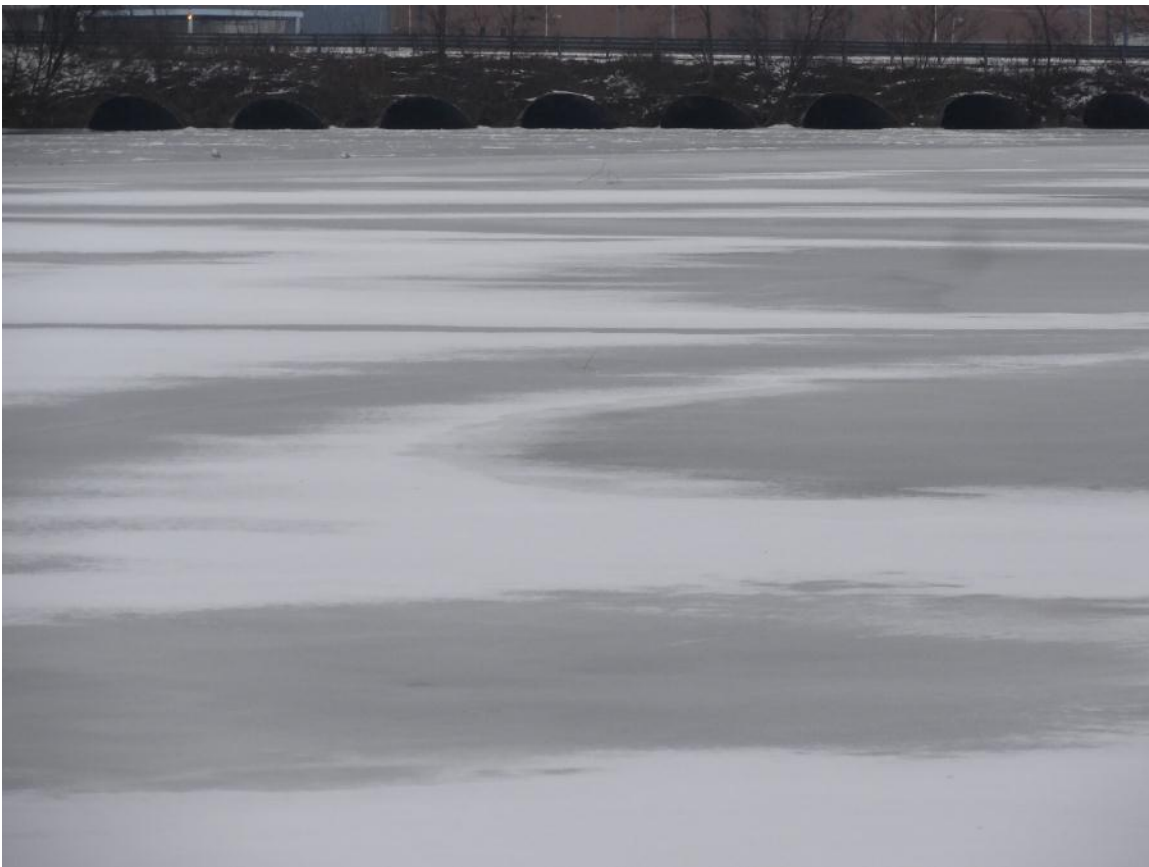
10. MP15.75 North Mill Pond culverts, area covered in ice.

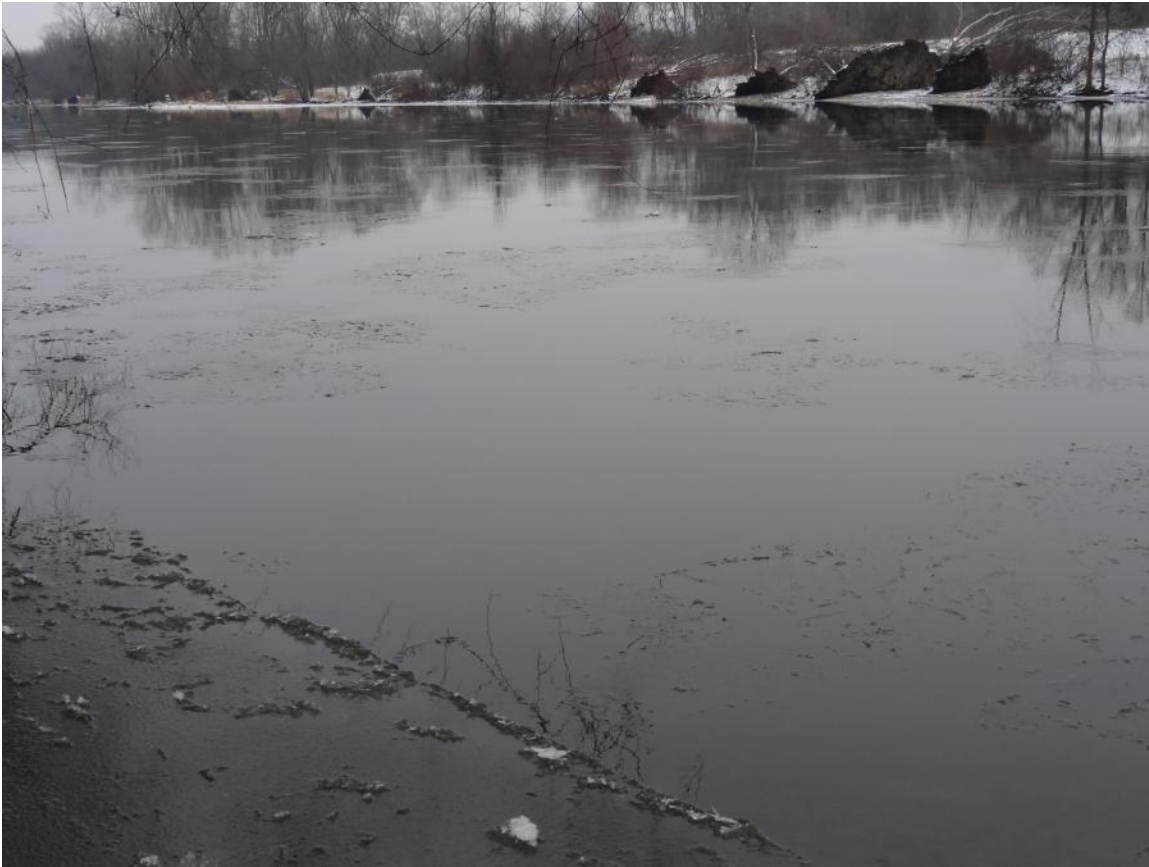
11. D2 Boat Launch, frazil ice observed flowing downstream in river channel.

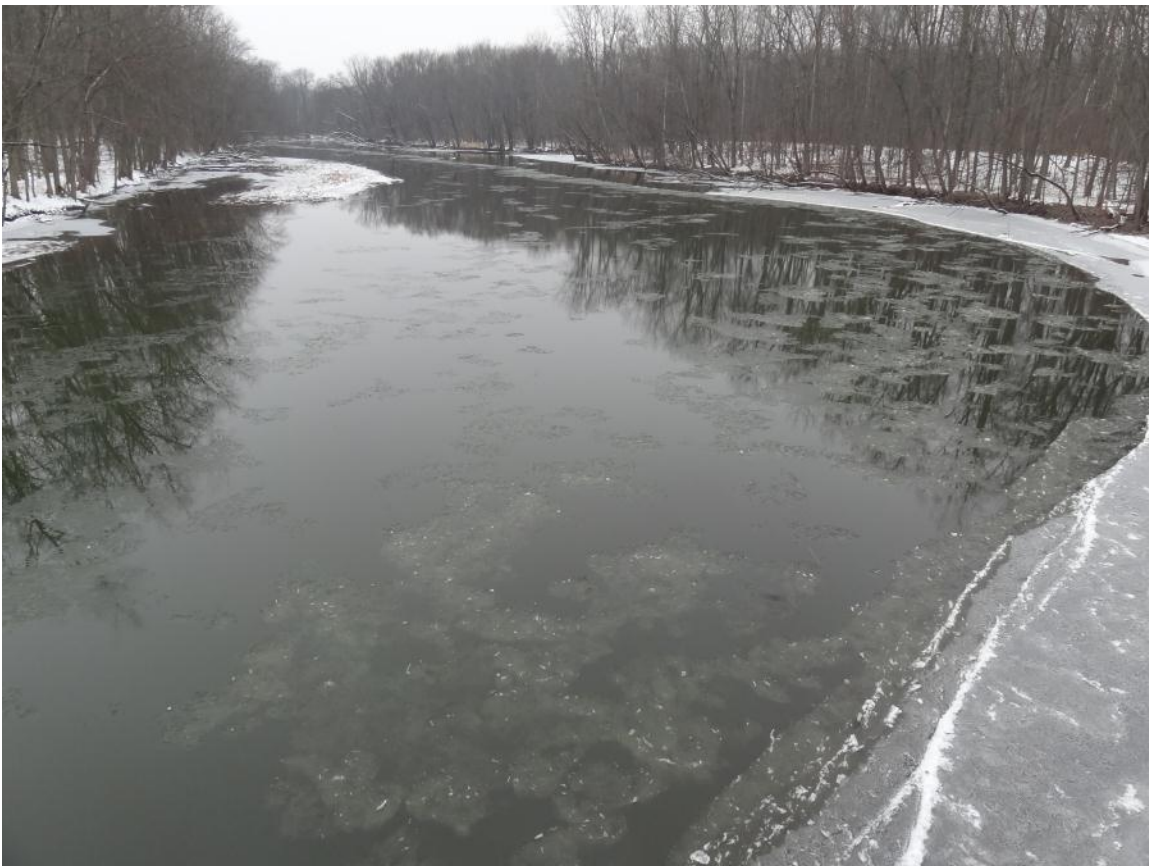
12. MP21.50, frazil ice observed flowing downstream in river channel.

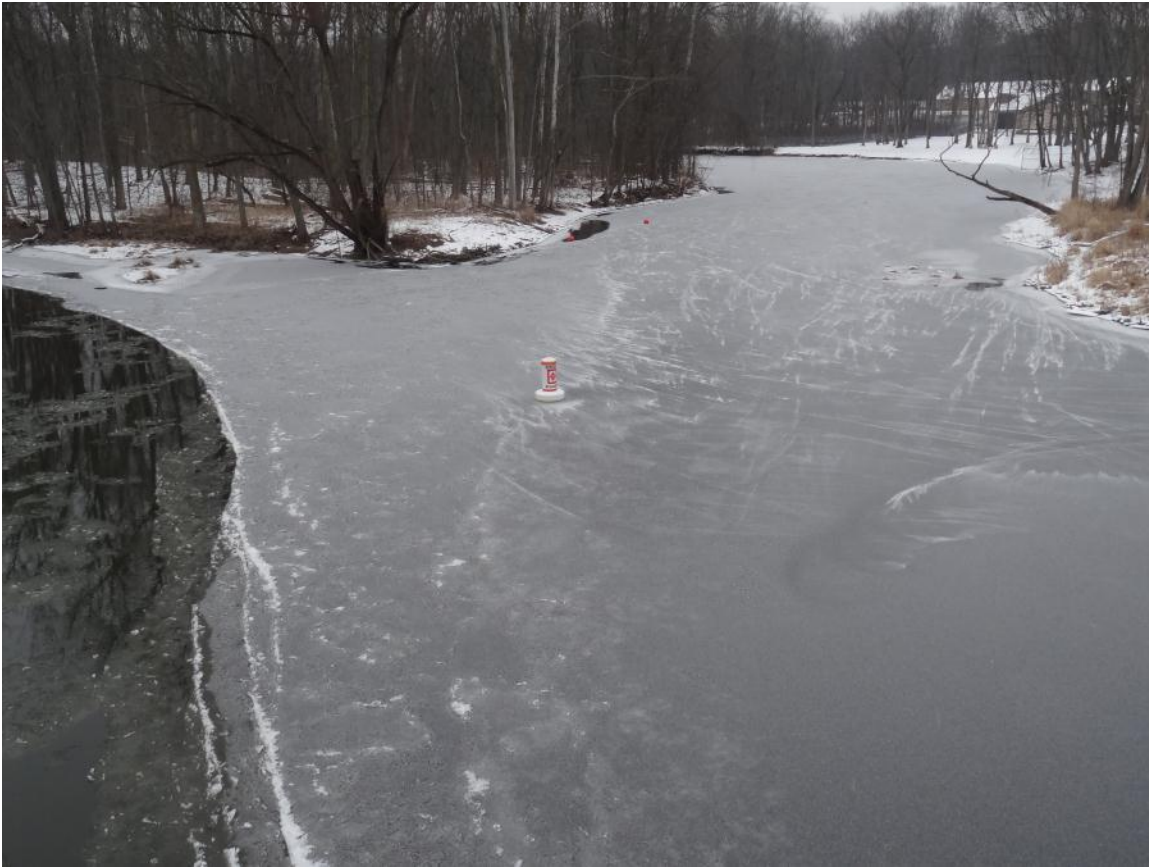
13. MP21.50 RDB, back channel of oxbow covered in ice.

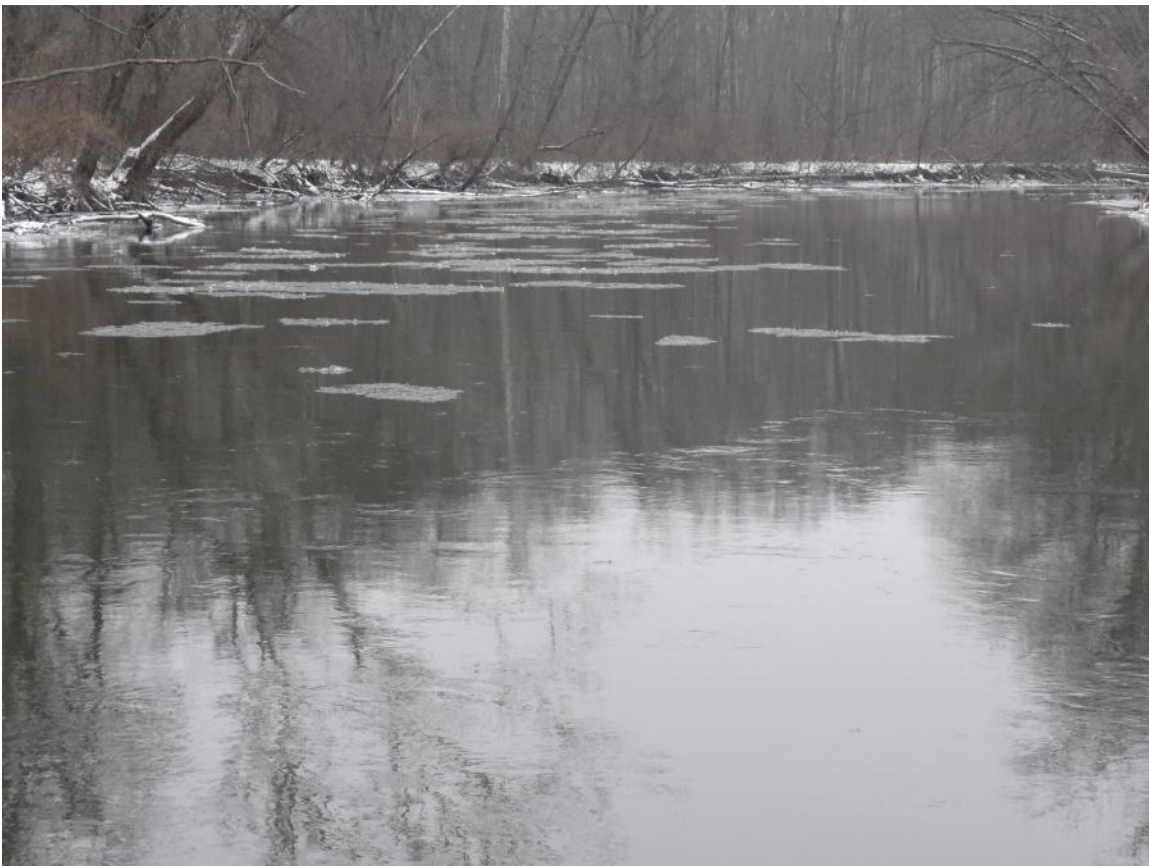
14. E2 Boat Launch. Frazil ice observed flowing downstream in river channel.

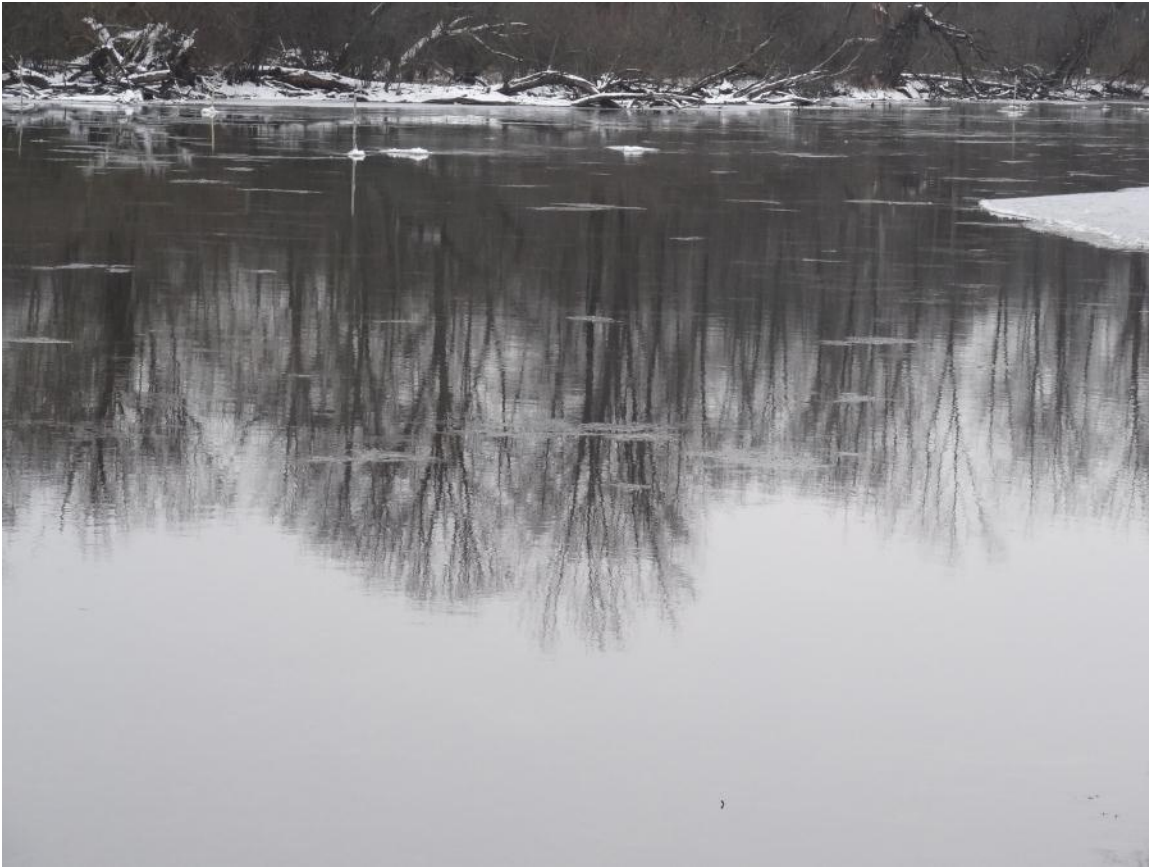
15. E3 Boat Launch. Small patches of frazil ice observed in river channel.

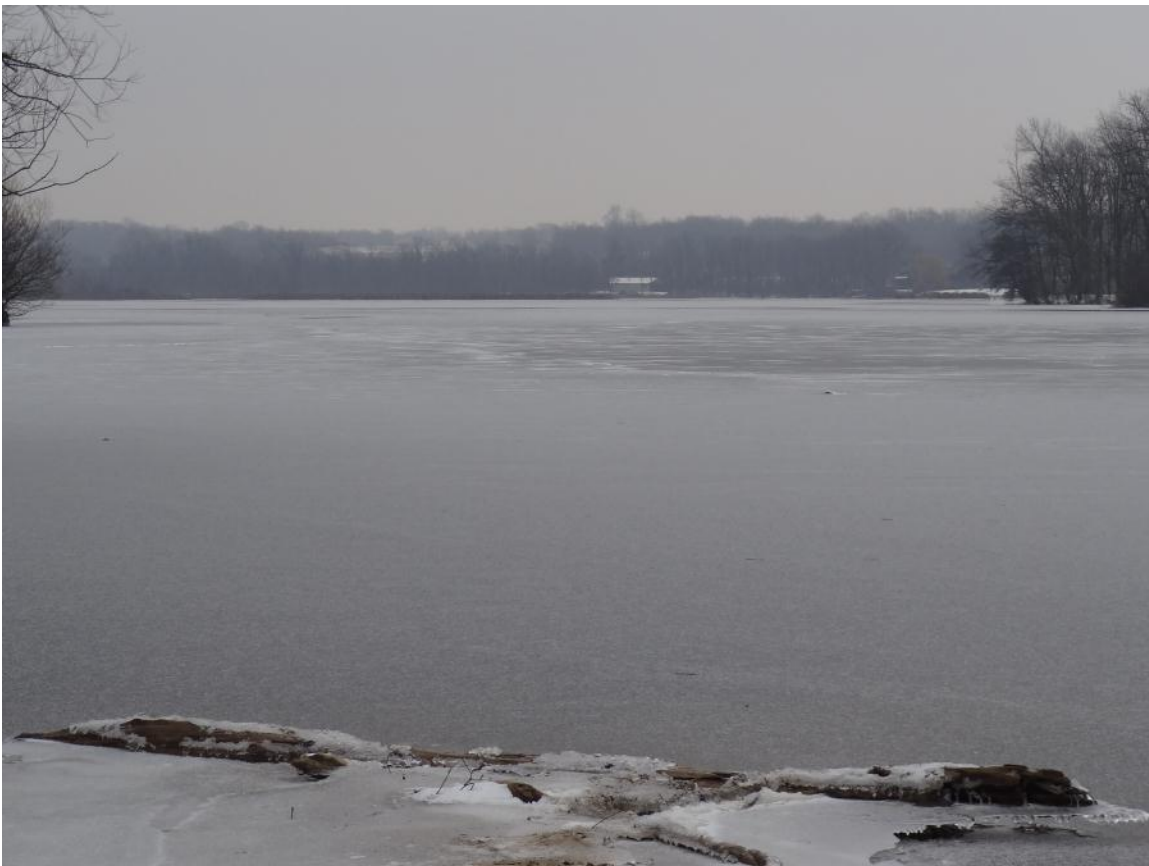
16. Former E4 Boom location looking east into Delta. Area covered in ice and snow.

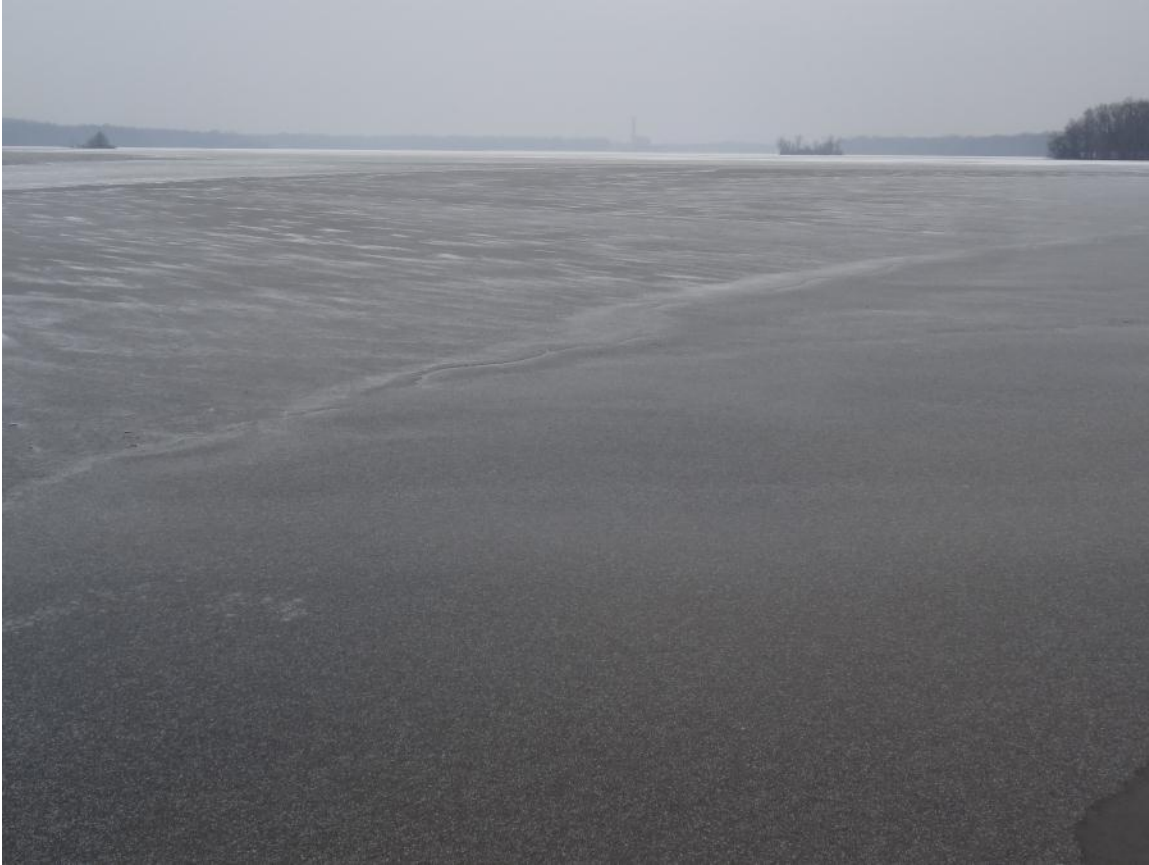
17. E4 Boat Launch. Morrow Lake covered in ice and snow.
